SILO INCIDENT – 5 December 2013

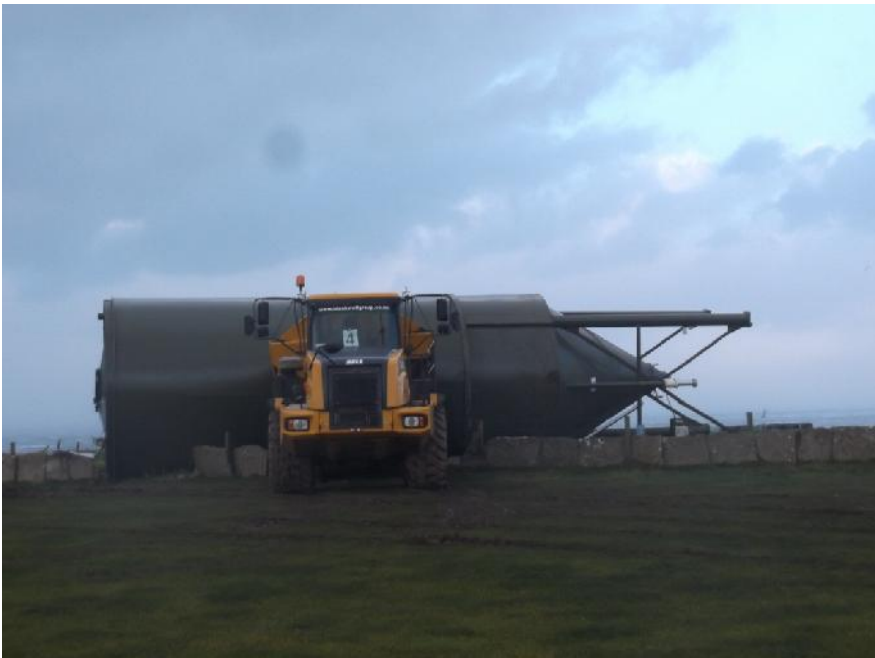
On the morning of 5 December 2013, it was noticed by a Graham Construction engineer that one of the silos had travelled approximately 450m across taxiways, the runway and neighbouring land coming to a rest in the field owned by D Henderson. Residents were immediately notified and action was taken to secure the silo using dumper trucks. It was apparent that the straps on this silo had failed at the connection with the grouted reinforcement bar. The other two silos remained securely in place. During that night/morning an average wind speed of 60mph with gusts of up to 80mph were recorded. Localised gusts could have been in excess of this.

The silo secured by dumper trucks

Following approval from B Grant on the morning of 6 December, once the wind speed had reduced, the silo was retrieved from D Henderson's field and re-located to the main runway where it was secured in

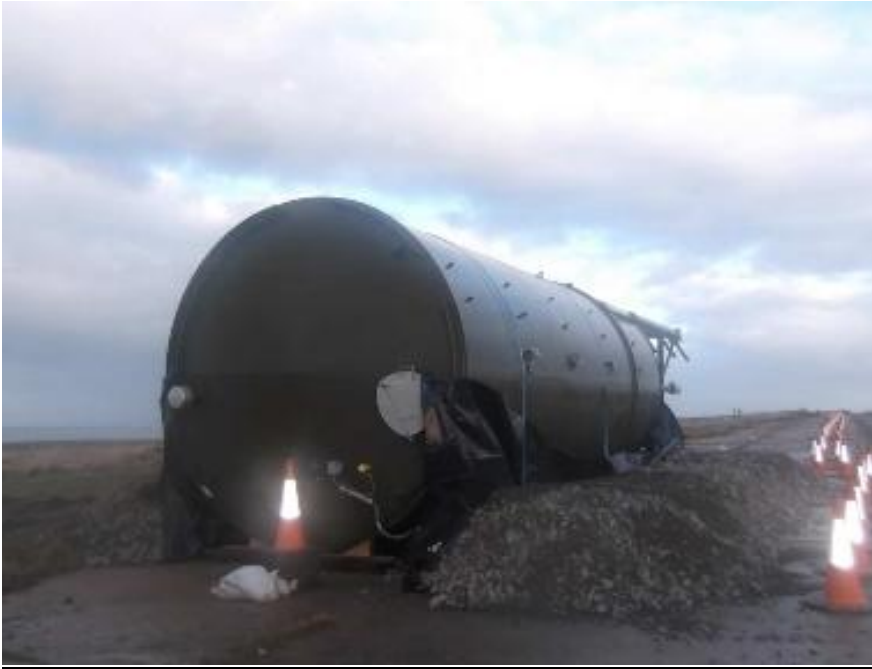
It is unclear why these two particular fasteners failed, as exactly the same arrangements were used on the other two silos and there was no sign of fastener failure only slight movement of the timber chocks. No one witnessed the initial movement of the silo, so it is difficult to ascertain the exact reason for the fastener failure, however, it is thought that possibly the ratchet straps were able to work loose in the high winds allowing the silo to move, thus dislodging the timber chokes which allowed the silo to move even more, ultimately shearing the fasteners. However, we are aware of the high winds experienced in Caithness and this should have been considered further in early calculations.

One of the two silos that remained in position with anti-roll bund

After the incident, the remaining two silos stored on the northern taxiway which had been strapped in a similar way, had the connection between the strap and the bar reinforced using a shackle fitted between the ratchet strap and the reinforcement bar. As a further measure a wind protection/anti-roll bund was installed using 6F2 material (graded crushed rock) on either side of the silo.
